S-262  
Old Bank of Marion  
Marion  
public

# Maryland Historical Trust State Historic Sites Inventory Form

Survey No. S-262

historic Bank of Marion

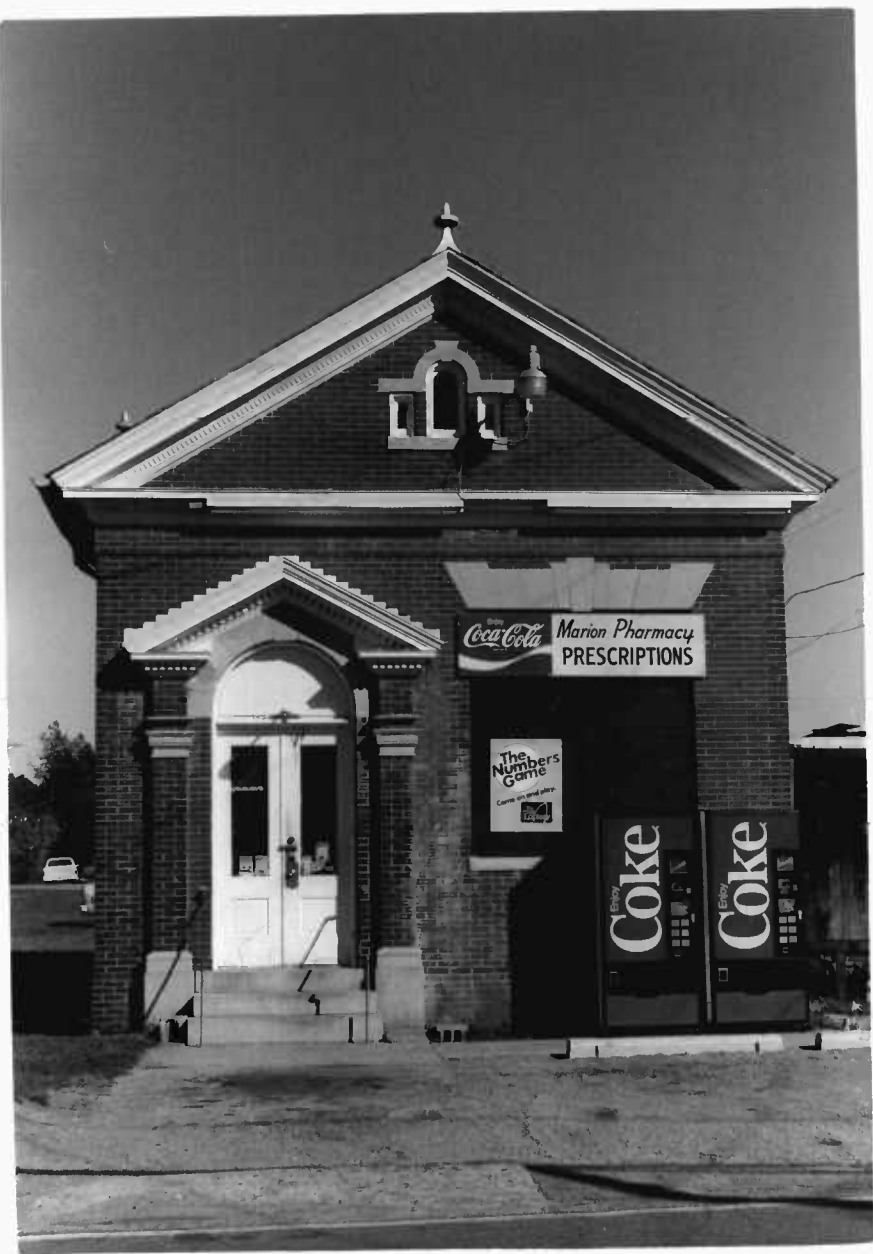
S-262

The two-bay main elevation has a classical pedimented entrance in the left (west) bay and a blocked-up window in the right (east) bay. A classical pediment caps the front elevation. The granite steps and a classical pedimented door frame surround the double-leaf glazed door. Brick pilasters rise on granite plinths and have granite capitals. The entablature and cornice pediment surround an arched transom with a segmental granite apron. The arched cornice has a row of dentils under the fascia as well as a crown molding.

Old Marion Bank  
Southwest Entrance  
Marion, Somerset County  
10/84, Paul Touart, Somerset County  
Neg./MD Historical Trust

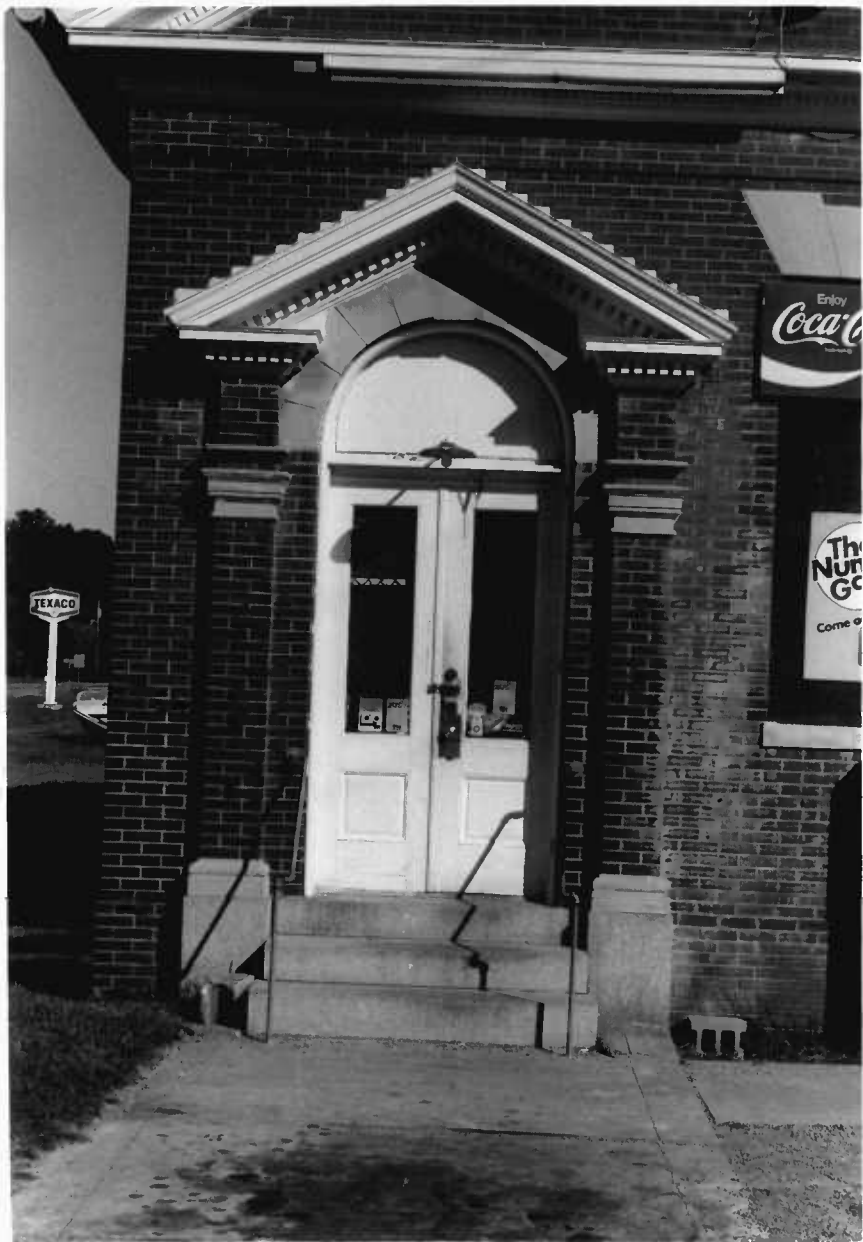
S-262

Old Marion Bank  
Southwest Entrance  
Marion, Somerset County  
10/84, Paul Touart, Photographer  
Neg./MD Historical Trust

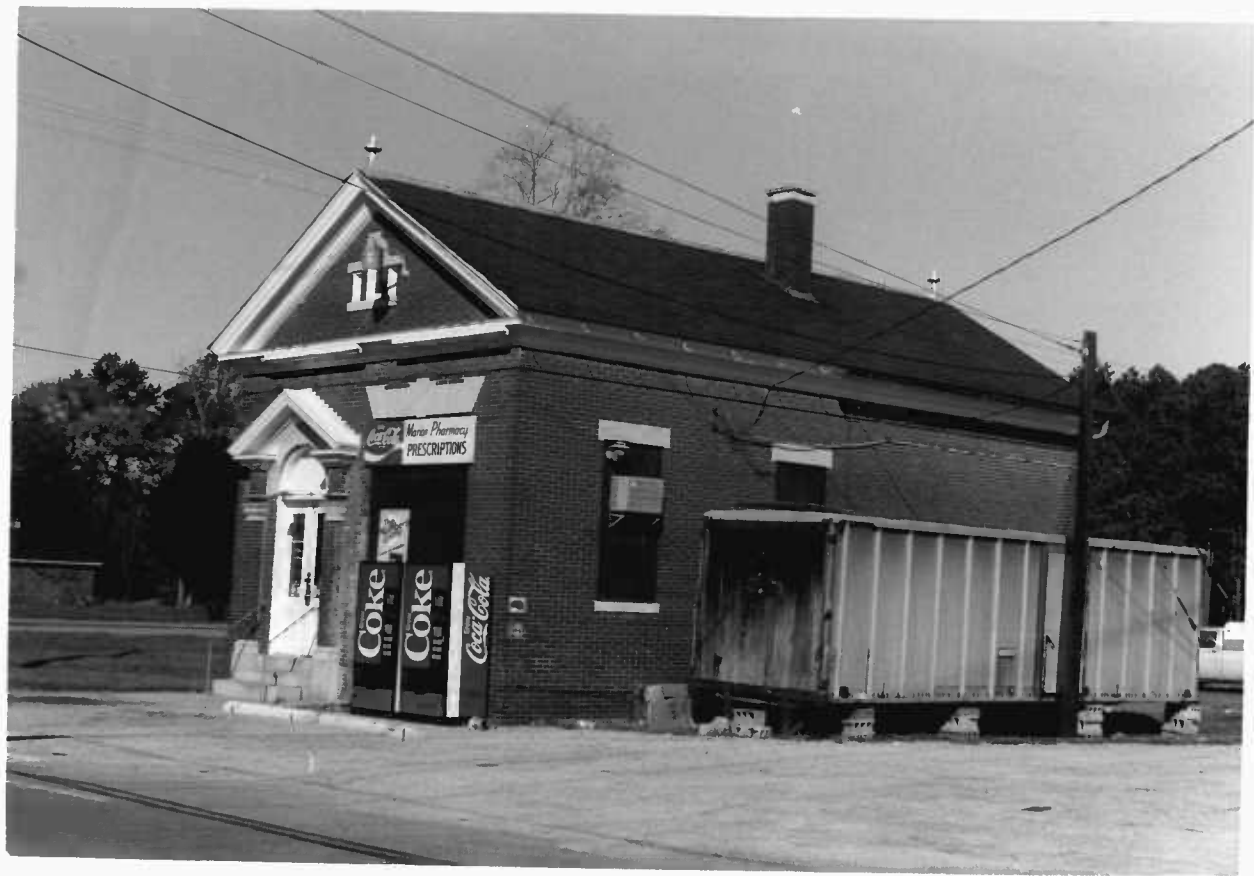
S-262

Both sides of the bank building have blocked up windows with plain stone lintels and sills. A narrow brick stove rises from the southeast slope of the roof. A metal ridge covers the roof peak and is embellished by a small finial at each end.

Old Bank of Marion

South Elevation
